**MISSION SAFETY EVALUATION
REPORT FOR STS-41**

Postflight Edition: November 15, 1990

Safety Division

National Aeronautics and Space Administration

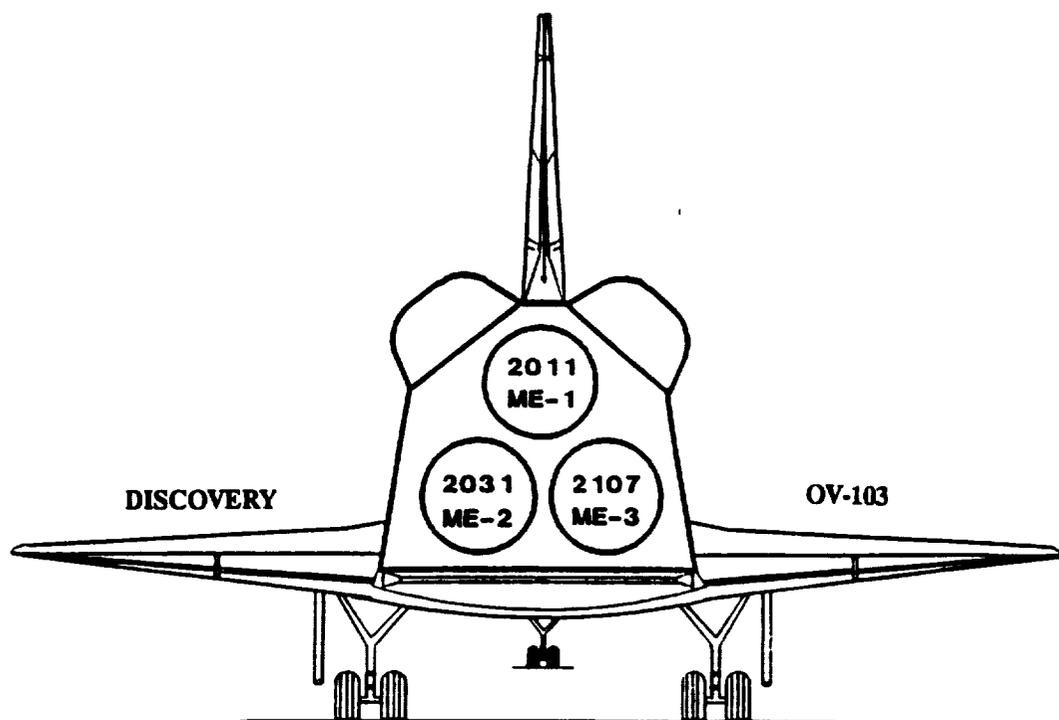
ENGINE	#2011	#2031	#2107
POWERHEAD	#2016	#2028	#2014
MCC*	#4005	#2019	#4002
NOZZLE	#4016	#4017	#4019
CONTROLLER	F24	F27	F25
FASCOS*	#17	#12	#29
HPFTP*	#5203R1	#4010R3	#6003R1
LPFTP*	#2030	#2120R1	#4007
HPOTP*	#2027R2	#2521R1	#2305R3
LPOTP*	#2126	#2120	#2216

- Launch Date: October 6, 1990
- Launch Time: 7:47 a.m. EDT
- Launch Site: KSC Pad 39B
- RTLS: KSC Shuttle Landing Facility
- TAL Site: Banjul, The Gambia
- Alternate TAL Site: Ben Guerir, Morocco
- Landing Site: Edwards AFB, CA, Concrete Runway 22
- Landing Date: October 10, 1990
- Landing Time: 9:57 a.m. EDT
- Mission Duration: 4 Days, 2 Hours, 10 Minutes
- Crew Size: 5
- Inclination: 28.45 Degrees
- Altitude: 160 Nautical Miles Circular/Direct Insertion
- Orbiter: OV-103 (11) Discovery
- SSMEs: (1) #2011, (2) #2031, (3) #2107
- ET: ET-39
- SRBs: BI-040
- SRMs: RSRM Flight Set #14
- MLP: MLP #2
